REPORT ON
ASTM PHASE I ENVIRONMENTAL SITE ASSESSMENT
AND LIMITED SUBSURFACE SAMPLING
AKRIDGE PARCEL AT BUZZARD POINT,
SQUARE 0607, LOT 0013
WASHINGTON, DC

File No. 40223-002 8 January 2014

Subject: ASTM Phase I Environmental Site Assessment and Limited Subsurface Sampling

Akridge Parcel at Buzzard Point, Square 0607, Lot 0013

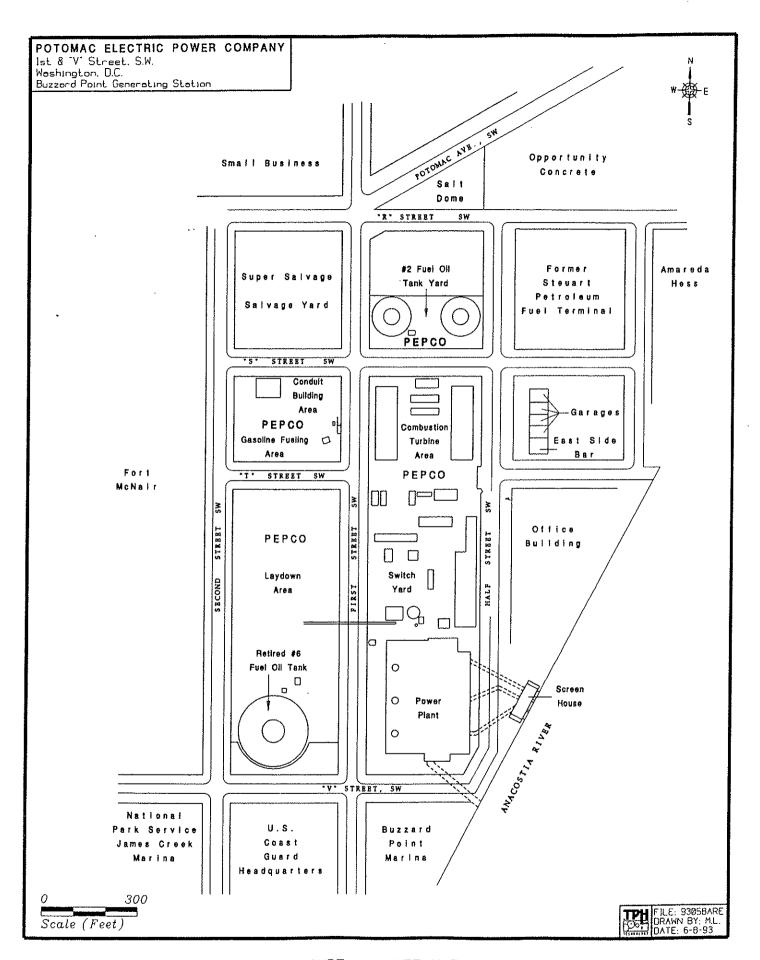
The retired #6 fuel oil tank and laydown area is west of the decommissioned power station. The retired #6 fuel oil tank is a 1.9-Million gallon AST, used to fuel the oil-fired steam generators via an underground pipeline buried under First Street. This tank was taken out of service when the power station was decommissioned in 1981. A fire fighting foam house is located next to the retired #6 fuel tank. This fire fighting foam house is still operable. The remaining portion of this area is used for storage by a private contractor and by the Federal Bureau of Investigation for vehicle storage. Prior to the construction of the #6 fuel oil tank and foam house, this area was used as a coal yard.

North of the retired #6 fuel oil tank area and west of the CT Yard is the former gasoline fueling and old conduit building area (PEPCO/Chevron site or 180 S Street site). This area consisted of a former maintenance building now used for storage, and an unmanned gasoline distribution area. The gasoline distribution area was supplied with gasoline via a 20,000gallon underground fiberglass reinforced plastic storage tank (assessed within the November 1993 Report). This tank was removed in early August 1993 as part of a scheduled cost cutting measure and not due to any known release problems. The tank had passed structural integrity pressure testing on July 31, 1992. DCRA directed that this area be assessed after initiating assessment of the CT Yard. Subsequent to the submittal of an assessment report for this site to the DCRA, DCRA issued a letter approving conditional closing of this case. However, the recent DCRA Directive issued in November 1994 required that the "180 S Street" site be assessed. Since this time, it was determined that the former gasoline fueling area site and the PEPCO/Chevron site are the same exact site at 180 S Street. In order to support the findings of the initial assessment and provide further areal wide information, an additional monitoring well (MW-21) was installed in this area in close proximity to MW-13 (installed to initially assess the property and used to gain the initial conditional closure).

FIGURE 1: SITE MAP

North of the CT Yard is the AST farm. This area contains two .411-million gallon ASTs, two truck unloading pads, and a fire fighting foam house. The ASTs service the combustion turbines in the CT Yard via an underground pipeline located beneath the eastern half of S Street between First and Half Streets, SW. This area was recently assessed to determine if it represented a potential source of the free-phase petroleum found beneath the CT Yard. Six monitoring wells were recently installed in the area of the ASTs and between the ASTs and the CT Yard along the northern side of S Street (MW-18, 19, 20, 22, 23 and 24).

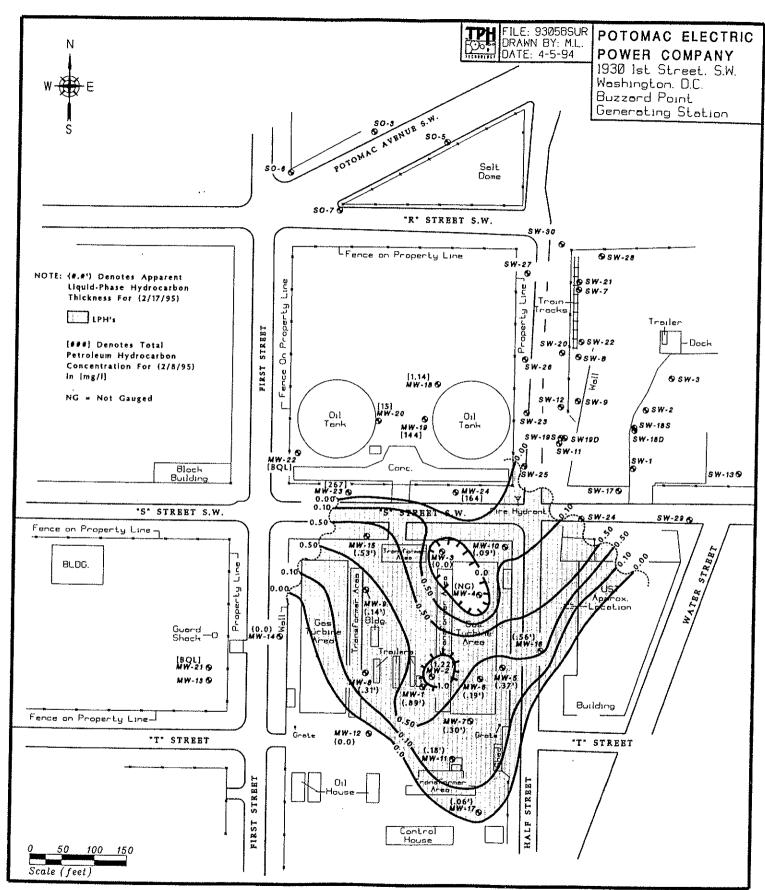
FIGURE 3: HYDROCARBON OCCURRENCE MAP (2/17/95)
CONTOUR INTERVALS (FEET)

As shown in Tables 3 and 4, dissolved hydrocarbon constituent were identified in water samples collected from all seven newly installed wells. The highest BTEX concentration measured in the recent monitoring well samples was in the sample collected from MW-23 (14.659 milligrams per liter, mg/l); the lowest was 0.00289 mg/l BTEX, as measured in the sample collected from MW-21, located at the 180 S Street site (former PEPCO/Chevron site). Total dissolved BTEX concentrations less than 0.1 mg/l were found in the water samples collected from MW-18, MW-19, MW-21 and MW-22. The remaining three wells contained 1.7638 mg/l (MW-20), 2.444 mg/l (MW-24) and 14.659 mg/l (MW-23).

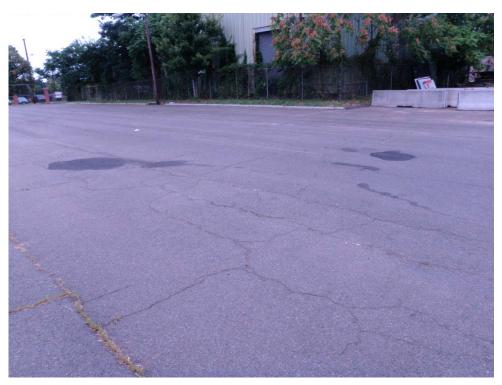
Apparent hydrocarbon stains were observed on the asphalt-paved portion of the subject site utilized as a parking lot. A crack was observed in the asphalt under one of these stains and a soil sample (GSS-607-13-1, see Figure 3) collected by Haley & Aldrich from beneath the asphalt revealed a total petroleum hydrocarbons – diesel range organics (TPH-DRO) concentration of 184 milligrams per kilogram (mg/kg). This TPH-DRO detection confirms the presence of minor petroleum contamination in shallow soil, exceeding the D.C. Municipal Regulations (DCMR) Tier 0 Soil Standard for TPH of 100 mg/kg. The vertical extent of impact is currently not known, although based on the relatively low concentration immediately beneath the staining, the degree of impact appears to be minor. The TPH-DRO detection may also be related to urban fill encountered in this boring.

Photo #1: Minor staining of asphalt in parking lot

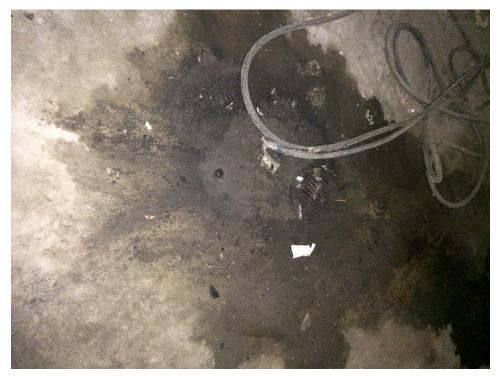
Explanation: Heavy staining of the concrete floor appearing to be caused by hydrocarbons

was observed immediately surrounding two floor drains, one in the northwestern portion and a second in the southeastern portion of the building. Although no cracks were apparent in the concrete in the areas where staining was observed, it is unknown whether the source of the stains has also migrated into these floor drains or where the floor drains discharge. In addition, the source of the staining could have penetrated the concrete floor. A potential therefore exists for apparent hydrocarbon spills or leaks to have migrated to the

Photo #2: Staining of concrete surrounding drain in northwestern portion of building

In summary, several RECs were identified during the comprehensive Buzzard Point Phase I assessment in August 2013 and subsequent Phase II sampling. An additional REC was identified during the December 2013 subject site visit of the storage building (staining around floor drains), which could impact the proposed development. We recommend that the outfall location for the drains be determined and that additional soil and groundwater sampling be performed to assess the potential subsurface impact from staining observed around floor drains inside the storage building.

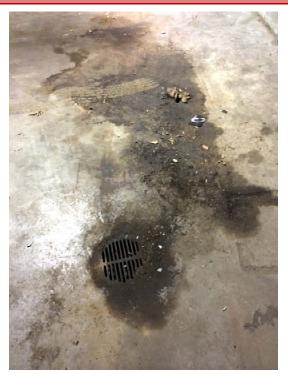
Photo #3: Staining of concrete surrounding drain in southeastern portion of building

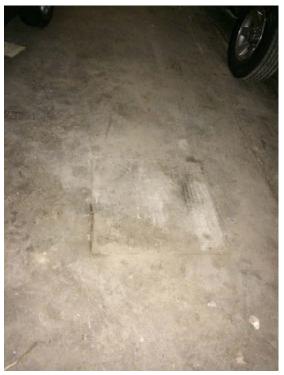
Photo #4: Concrete patch in concrete inside building

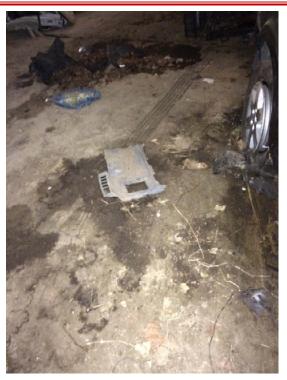
Photo #5: Staining of concrete in building

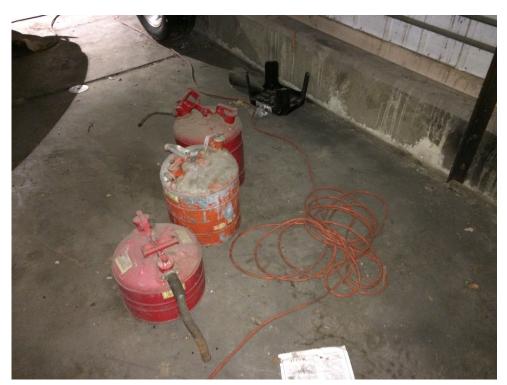
Photo #6: Empty jerry cans in building

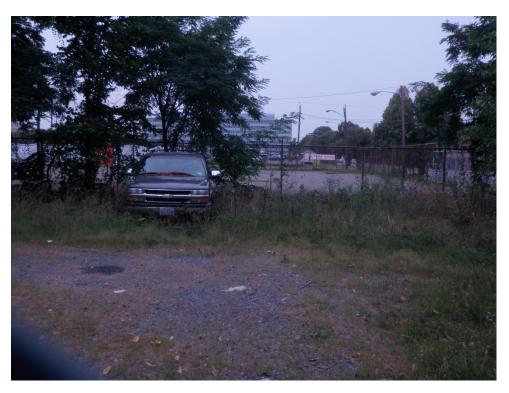
This Phase I assessment revealed the following *de minimis* condition: during the subject site visit performed in August 2013, minor stains were observed on loose gravel west of the building in the northwestern portion of the lot maintained by the United States Park Police. On a subsequent subject site visit in December 2013, the staining was no longer visible. No odors or stressed vegetation were encountered during either visit, suggesting that the staining was superficial in nature and unlikely to have migrated to the subsurface.

Photo #8: Staining of gravel in northwestern portion in August 2013
